RE: Request for Information ("RFI") Pursuant to Section 308 of the Clean Water Act
Compliance Evaluation Inspection Report for CEI conducted on April 5, 2016 at Harris
Camden Terminal
Docket No. CWA-IR-17-001

COMPLIANCE EVALUATION INSPECTION REPORT

Compliance Evaluation Inspection: Harris Camden Terminal Co.	
Inspection Date: April 5, 2016	Inspection Time: 9:20AM – 1:00PM
EPA Inspector: Cyndy S. Kopitsky, Environmental Scientist, USEPA Region 2, DECA, Water Compliance Branch (212) 637-3832 & Andrew Dinsmore, Stormwater Team Leader USEPA Region 3 (215) 814-2788	
NJDEP Representative: Steven Mathis, 856-614-3655	
On-Site Representative: Garrett Marrazzo, & Thomas Harris III, 305-458-7100	
Site Information: <div style="text-align:center">Harris Companies 2201 Mt. Ephraim Avenue Camden, New Jersey 08104 SPDES No. NJG0161713</div>

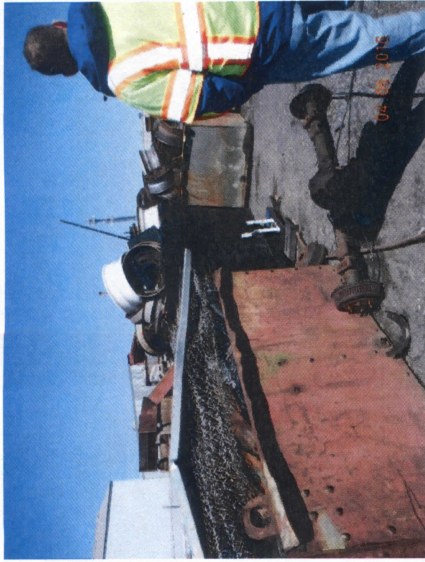
DSCN7025

- 1) As required in the permit Part E.3. Best Management Practices, include a list of the BMPs that are implemented at the facility in the areas regulated by this permit as identified in the mapping requirements in order to eliminate the exposure of source materials and/ or industrial activity to stormwater discharges. The SWPPP describes and recommends that all containers shall be covered at all times, except when materials are placed in them. During the inspection, EPA noted that all dumpsters were uncovered, there was no indication that covers were available or used during rain events, in one instance the cover was broken, and /or the dumpsters were leaking fluids as seen in DSCN7025.JPG, DSCN7027.JPG, DSCN7030.JPG, and DSCN7031.JPG.

DSCN7020.JPG	Harris Terminal Plot Plan and catch basin
DSCN7021.JPG	Harris Terminal Plot Plan and catch basin
DSCN7022.JPG	Open dumpster, SPI Corp. Drywall spill
DSCN7023.JPG	Drain/partly open to larger objects
DSCN7024.JPG	Open dumpster/Rusty scrap content
DSCN7025.JPG	Open dumpster/Rusty scrap content
DSCN7026.JPG	Scrap metal piles outside Bldg.#21
DSCN7027.JPG	Scrap metal piles outside Bldg.#21
DSCN7028.JPG	Cement materials outside dumpster
DSCN7029.JPG	Oil stains
DSCN7030.JPG	Leaking dumpster
DSCN7031.JPG	Leaking dumpster into blocked drains
DSCN7032.JPG	Drain
DSCN7033.JPG	Sediment collection
DSCN7034.JPG	Sediment collection
DSCN7035.JPG	ReCommunity scrap piles uncontained
DSCN7036.JPG	ReCommunity Operations-emissions
DSCN7037.JPG	ReCommunity scrap
DSCN7038.JPG	ReCommunity operations
DSCN7039.JPG	ReCommunity sediment collection
DSCN7040.JPG	ReCommunity Uncontained recycle scrap
DSCN7041.JPG	Moving debris/waste directly into drains

1. No later than thirty (30) calendar days of receipt of this RFI, submit documentation with accompanying photographs of the measures taken to address the Potential Violation and each of the Areas of Concern specified in the enclosed Inspection Report.
2. No later than thirty (30) calendar days of receipt of this RFI, submit revised detailed Facility maps of the entire drainage system, all drainage pipes, direction of flow and clean water diversions.

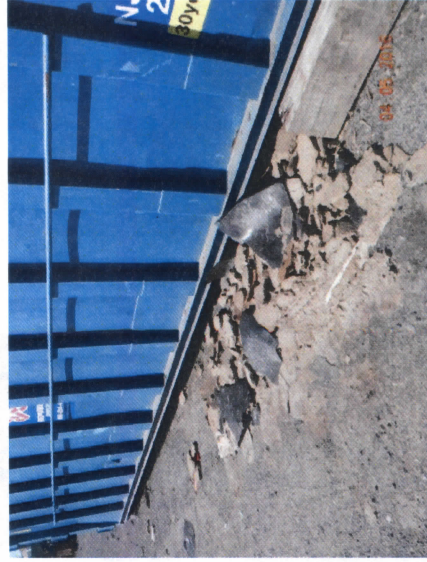
DSCN7028

- 2) EPA noted a sediment collection, drywall, and materials outside of the dumpsters and several blocked storm drains at of the facilities as required in D.1.a. of the permit which states that the owner or operator must keep clean all exposed areas that are potential sources of pollutants. At the time of the inspection there was drywall on the ground near the dumpsters, cement type materials outside the dumpster, and materials around a broken drain as seen in photos DSCN7022.JPG, DSCN7023.JPG, and DSCN7028.JPG.

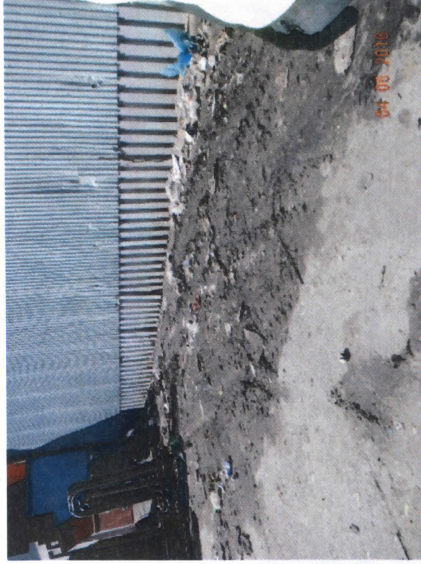
DSCN7033

During the walkthrough of Harris Terminal, EPA observed that the dumpsters on the site were uncovered and several were leaking fluids. Several drains were partially blocked and required cleaning. Observations also included an area of the facility lot that had an accumulation of sediment collecting against the building as seen in photo DSCN7033.

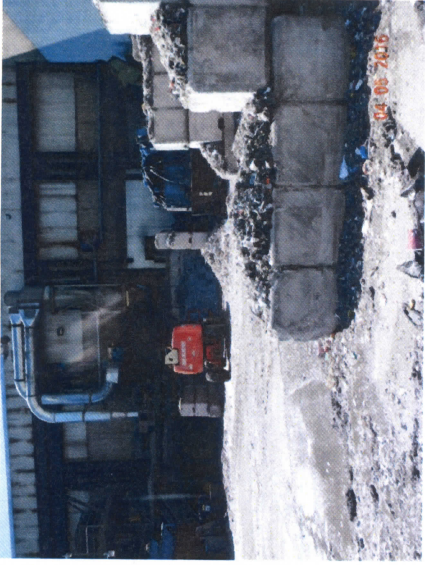
DSCN7036

- 1) As required by Part C.1.a. of the permit, every facility authorized under the Industrial Stormwater General Permit shall eliminate the exposure of source materials and/or industrial activities to stormwater discharges as required in Part 1.D. At the time of the inspection, ReCommunity was sweeping and plowing recycling operation waste materials, some of which were directly discharged into the storm drains as seen in photos DSCN7041.JPG, DSCN 7042.JPG, therefore in violation of Part C.1.a. of the permit. In addition, there were materials stored in outdoor bins and exposed to stormwater, as well as some processing areas appeared to be emitting materials into the air as seen in photos DSCN7036, DSCN7038, and DSCN7040.

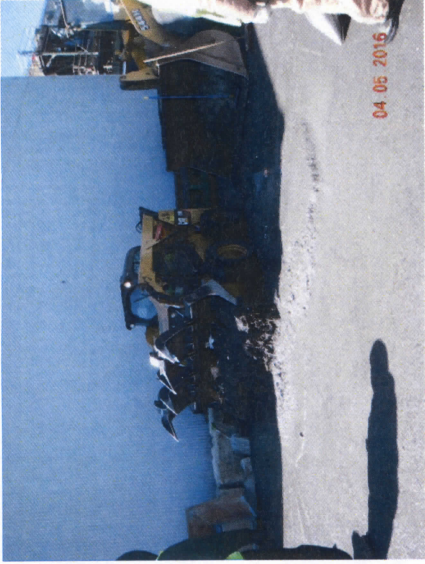
DSCN7041

During the walkthrough EPA observed the ReCommunity operations. It was noted that facility staff were attempting to plow, shovel/relocate waste and scrap material on the majority of the receiving areas, and appear to have directed pollutants into and towards the nearest drain on the property. Additional observations included recycling plant operations that were being conducted outside of any protective cover or containment.

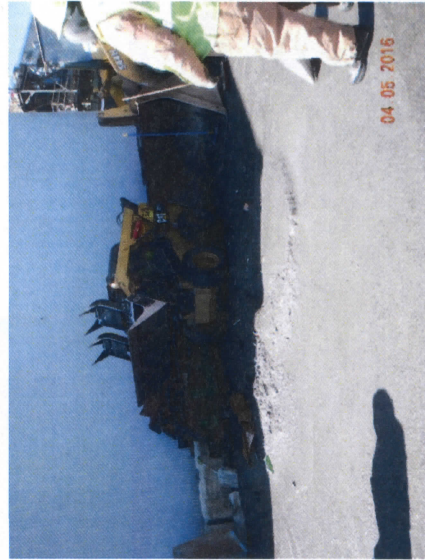
DSCN7042

DSCN7042.JPG	Moving debris/waste directly into drains
DSCN7043.JPG	Moving debris/waste directly into drains
DSCN7044.JPG	Equipment at ReCommunity
DSCN7045.JPG	Equipment at ReCommunity
DSCN7046.JPG	Sediment pile
DSCN7047.JPG	Unpermitted Construction area
DSCN7048.JPG	Unpermitted Construction area
DSCN7049.JPG	Drain at construction area
DSCN7050.JPG	Drain area
DSCN7051.JPG	Drain area
DSCN7052.JPG	Drain area
DSCN7053.JPG	Drain area and erosion
DSCN7054.JPG	Drain area and erosion

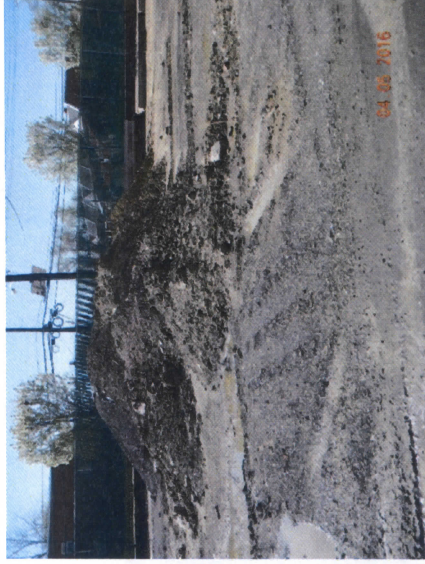
DSCN7046

- 2) Pursuant to Part I.12.a. of the permit, this permit does not authorize the discharge of stormwater that is associated with construction activities (see subparagraph 1x of the definition of "stormwater discharge associated with industrial activity" and the definition of "stormwater discharge associated with small construction activity" in N.J.A.C. 7:14A-1.2). In general, this is the discharge of stormwater to surface water from construction activity that disturbs one or more

acre(s). Any facility that operates a construction site with such a discharge shall submit a separate Request for Authorization (RFA) or individual NJPDES Discharge To Surface Water (DSW) permit application for that discharge. An RFA submitted for the Basic Industrial Stormwater General Permit does not qualify as an RFA for such a discharge as seen in photos DSCN7046.JPG, DSCN7047.JPG, DSCN7048.JPG and DSCN7049.JPG.
